An aging management program for neutron absorber materials in SFPs

EPRI's multiyear research provides nuclear plants with an efficient aging management program that ensures criticality safety margins are maintained for spent fuel pools.

By Hatice Akkurt

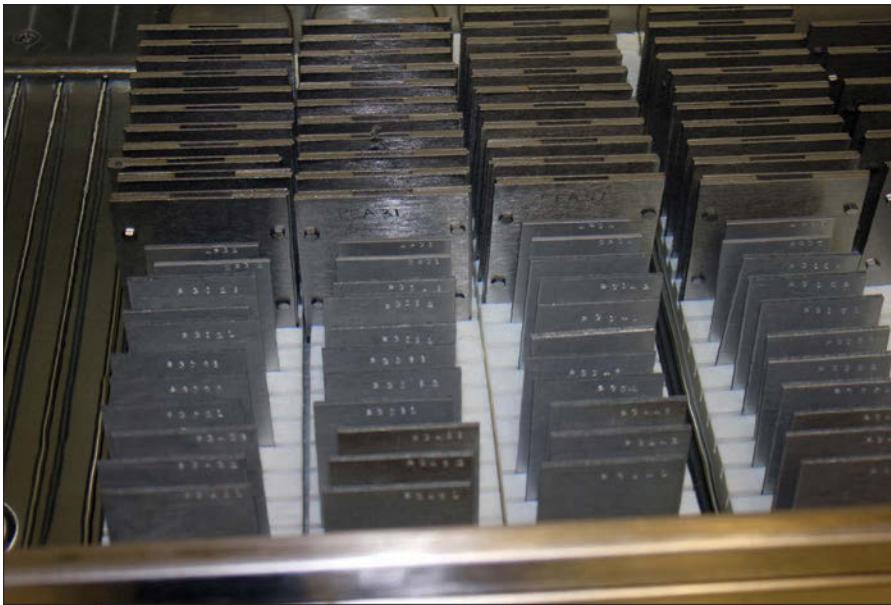
Fig. 2. BORAL coupons set in a test bath.

rate. The coupons, bare in the front and with stainless steel (SS) encapsulation in the back, are shown in Fig. 2, in one of the test baths.

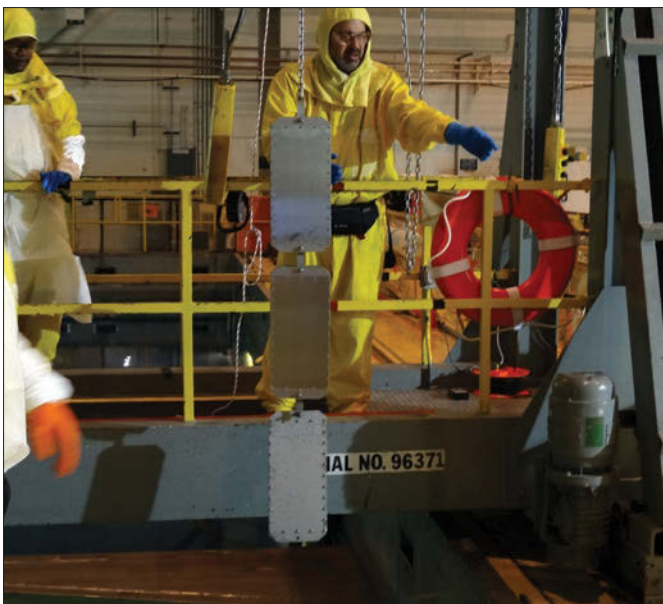
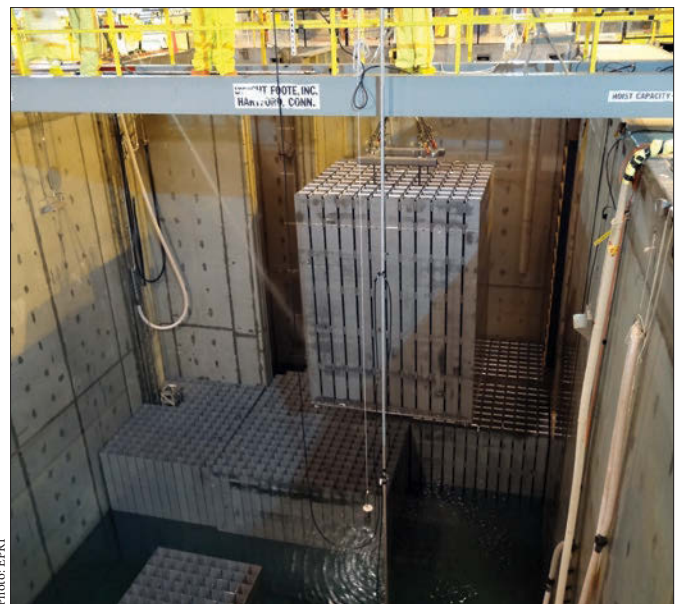
Fig. 6. Coupon tree removal (left) and rack module removal (right) from the Zion SFP.

previously, were removed for laboratory analysis and compared against the coupon and *in situ* measurement results. All panels were inspected following removal and cutting. The panels were generally in very good condition. Two of the panels were damaged outside of the pool due to plasma torch cutting and developed blisters. Out of the remaining 12 panels, only one section for one of the panels showed a small blister. The panels showed general and localized corrosion and flow patterns, but nothing that raised concerns regarding their ability to maintain criticality safety margins. Figure 6 shows the coupon tree removal (left) and rack module removal (right) from the Zion SFP.
