Bringing Down West Valley's Vit Plant

After demolishing West Valley's vitrification facility late last year, crews are in the final stages of bringing down seven ancillary support buildings.

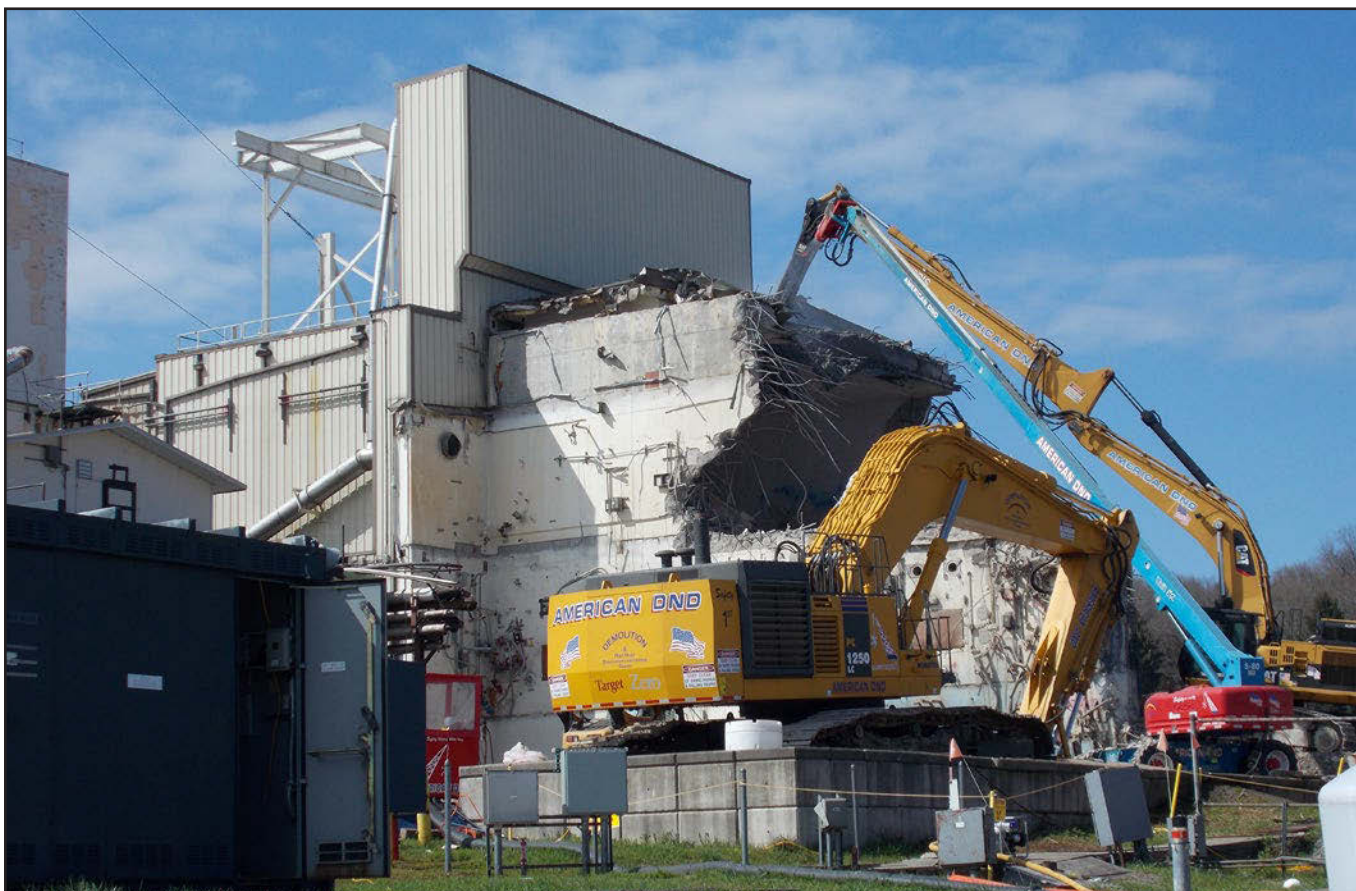
Above: CHBWV employees and subcontract workers with American DND tear down portions of West Valley's vitrification plant in May 2018. Demolition of the main facility, a 10,000-ft², 50-foot-tall building made of thick, reinforced concrete walls, was completed in September 2018. Using heavy equipment and specialized tools, workers tore down the building in three phases, including the safe removal of four in-cell coolers weighing 7,188 pounds each, six shield windows, and a 38,000-pound process crane. In the final phase of demolition, crews removed two doors—one weighing 60 tons, the other 100 tons—as well as cranes and other equipment.

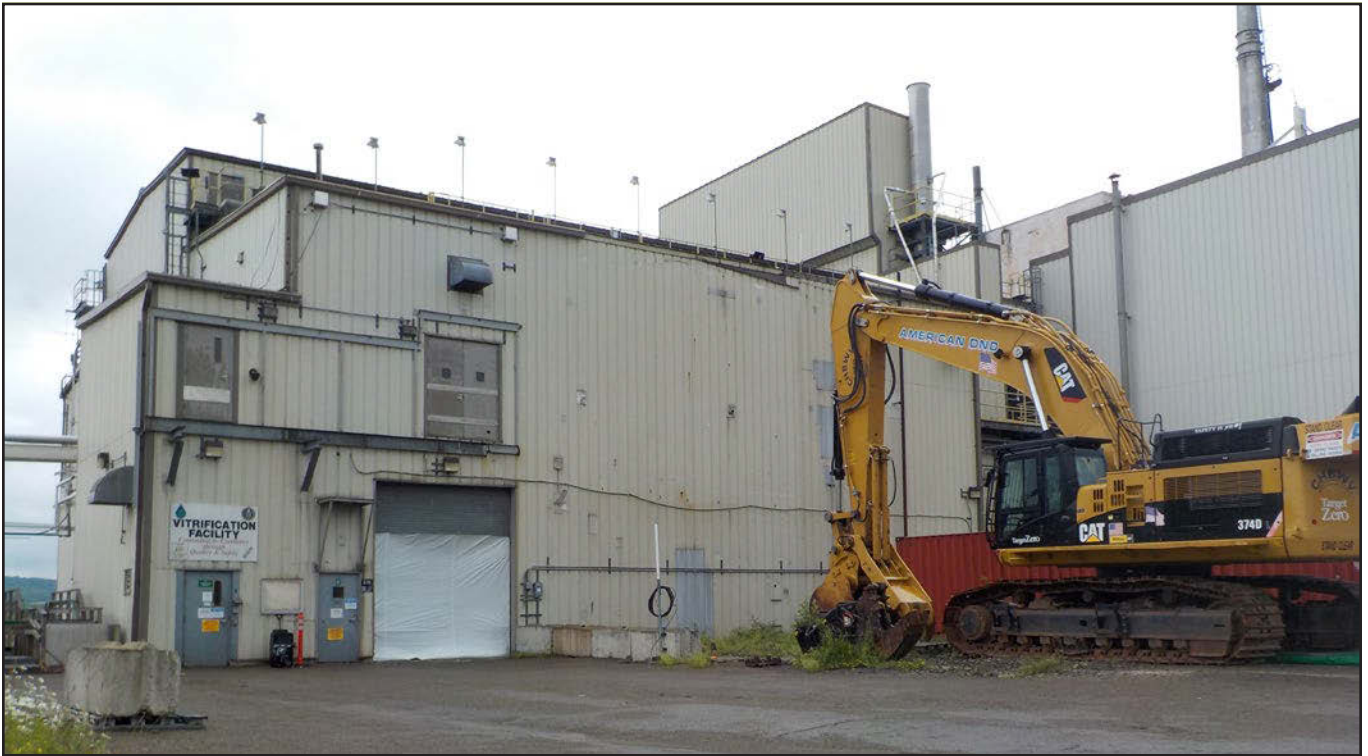
The vitrification plant before crews began demolition work.

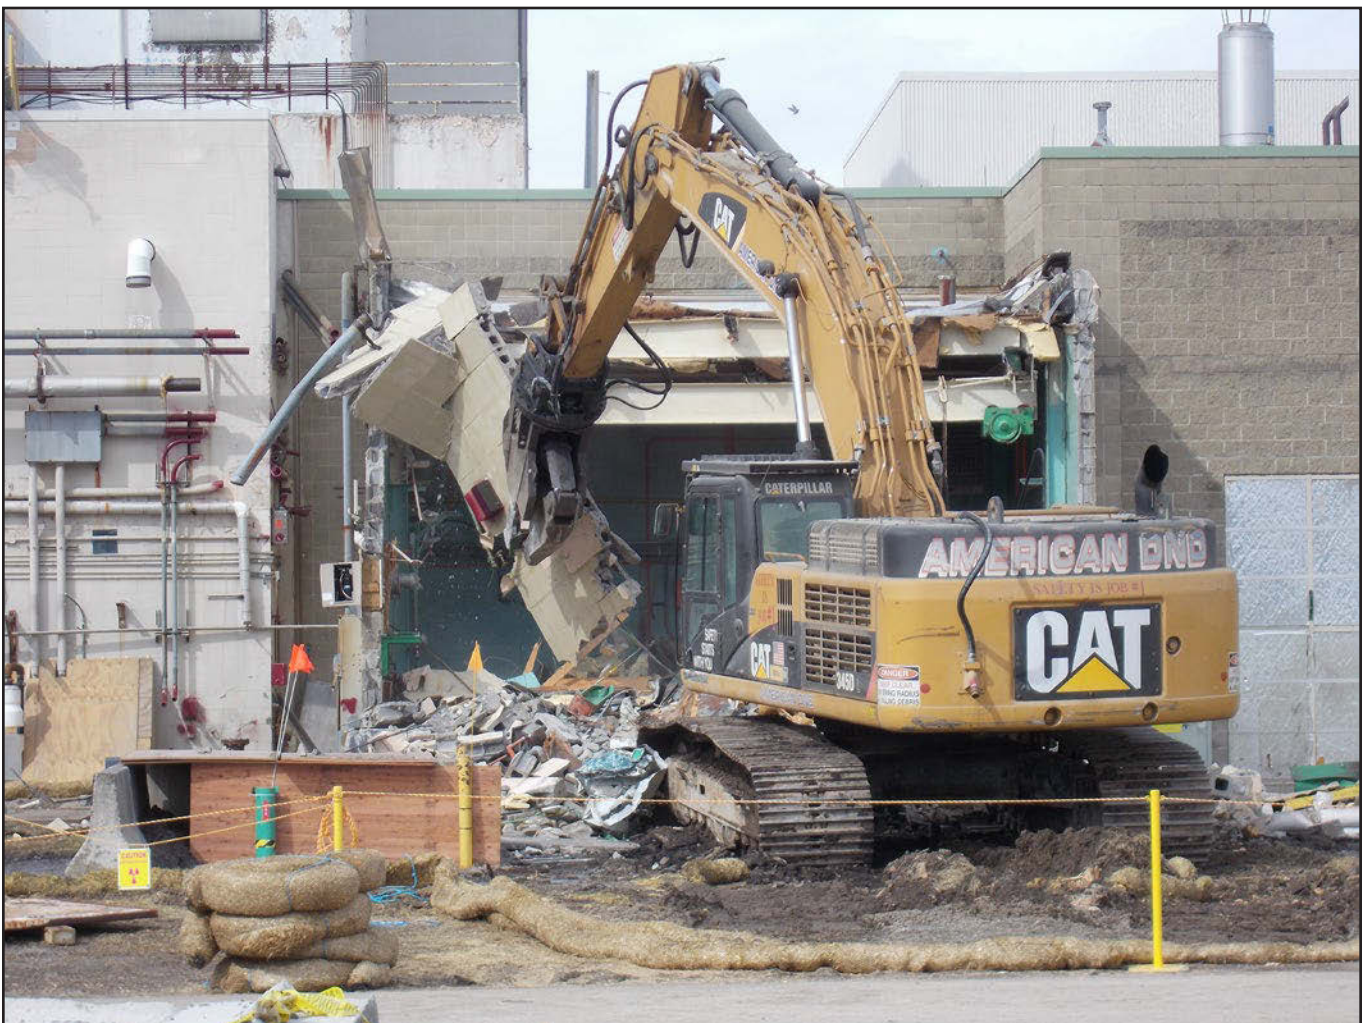
The West Valley laundry facility was one of seven ancillary support buildings to be demolished. Originally built in 1964 as the site's maintenance building, the support structure later became the laundry facility in the early 1970s. The 1,456-ft² building was constructed of concrete block, along with a steel frame and concrete slab on grade.

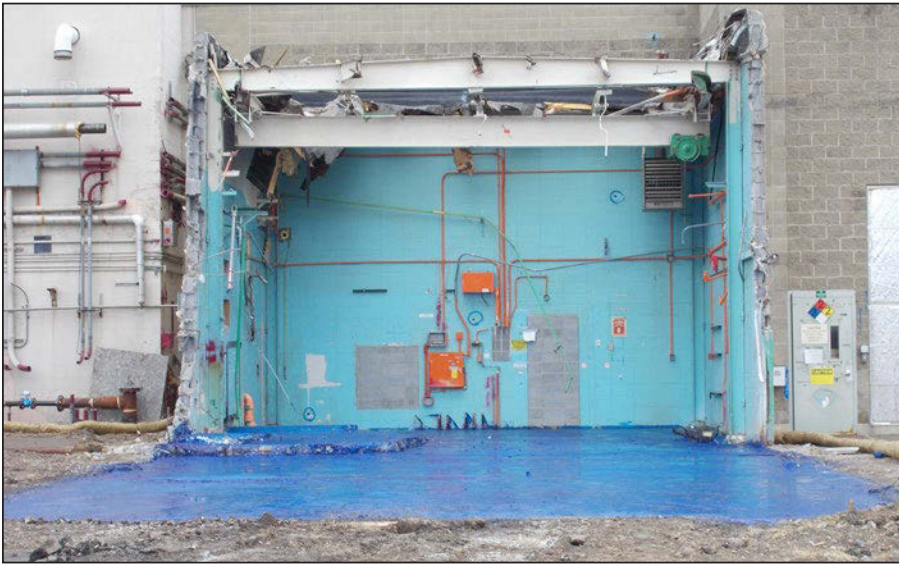
Left: The laundry facility was removed to slab, which was painted to encapsulate any remaining contaminants.

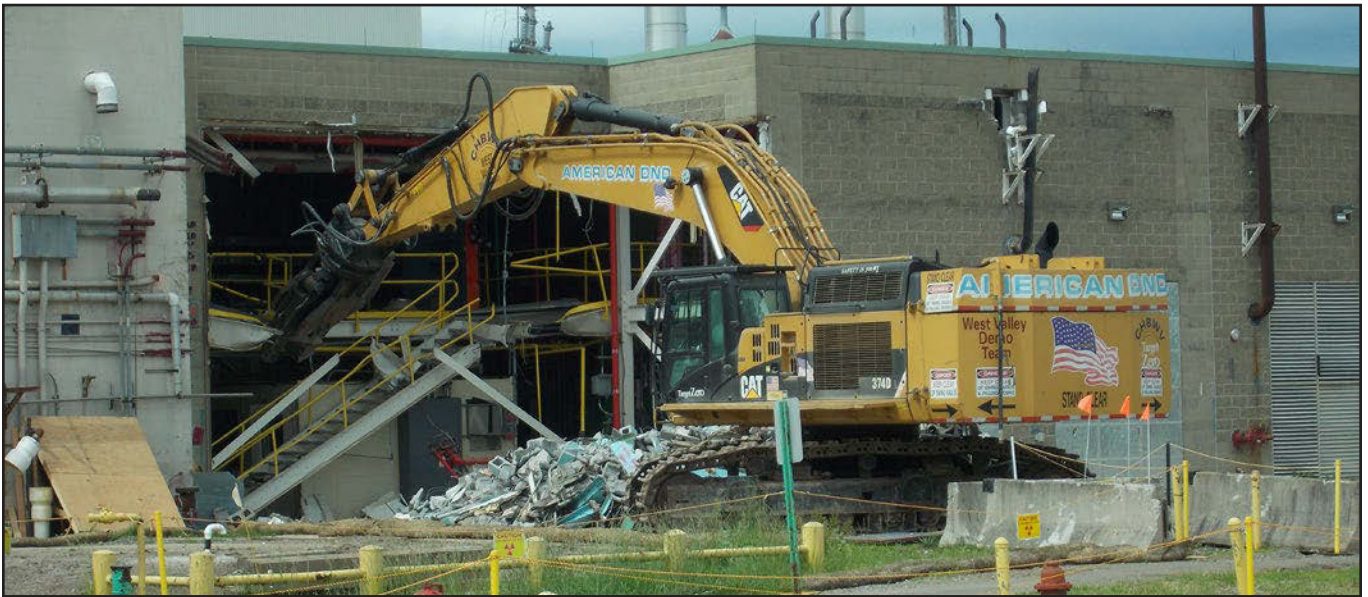
Below: Demolition crews with American DND remove the stairs from the utility room extension building. The support building housed two oil-free air compressors to supply breathing air and instrument air to the site, two boilers to provide steam for heating and process operations, an emergency generator for the site, a control room for utility operations, and an electrical switchgear room that supported the building and its equipment.

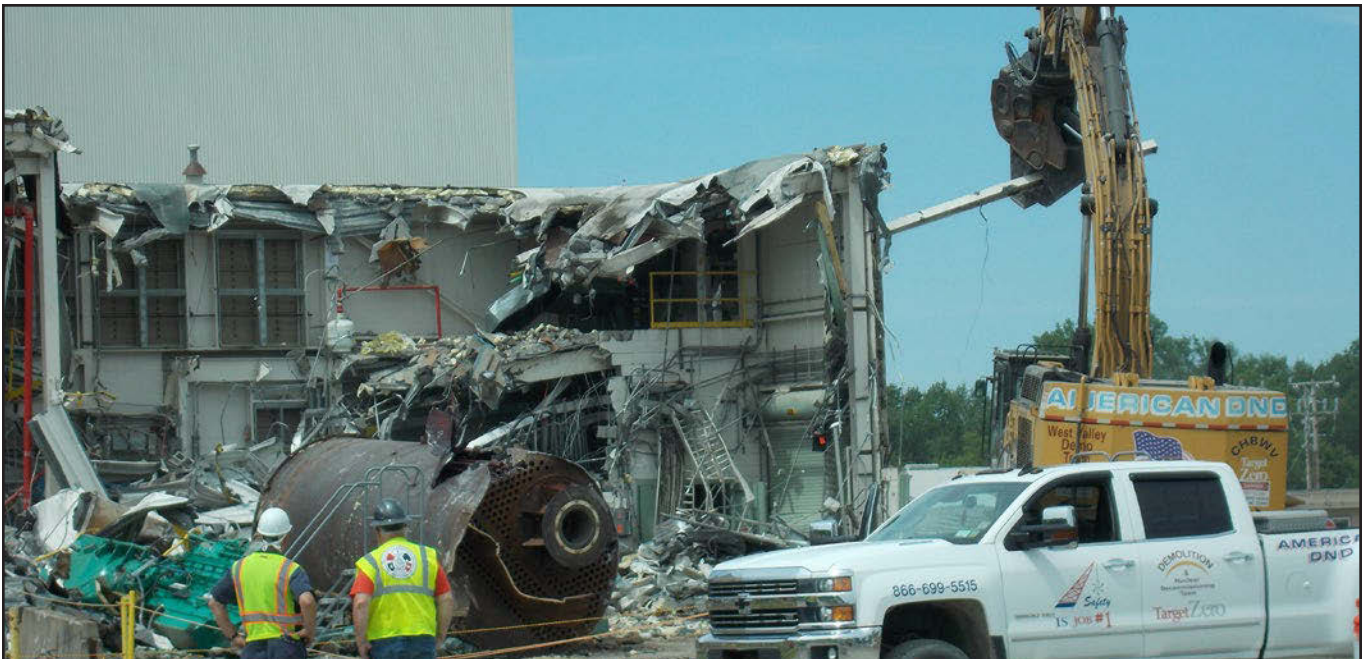
A steel beam welded by a hydraulic excavator is used to bring down the walls of the utility room extension. The room was added to the main plant utility room to help augment the site's aging electrical supply system, preventing electrical outages or other complications as the facility melted West Valley's high-level radioactive waste into a stable glass form.

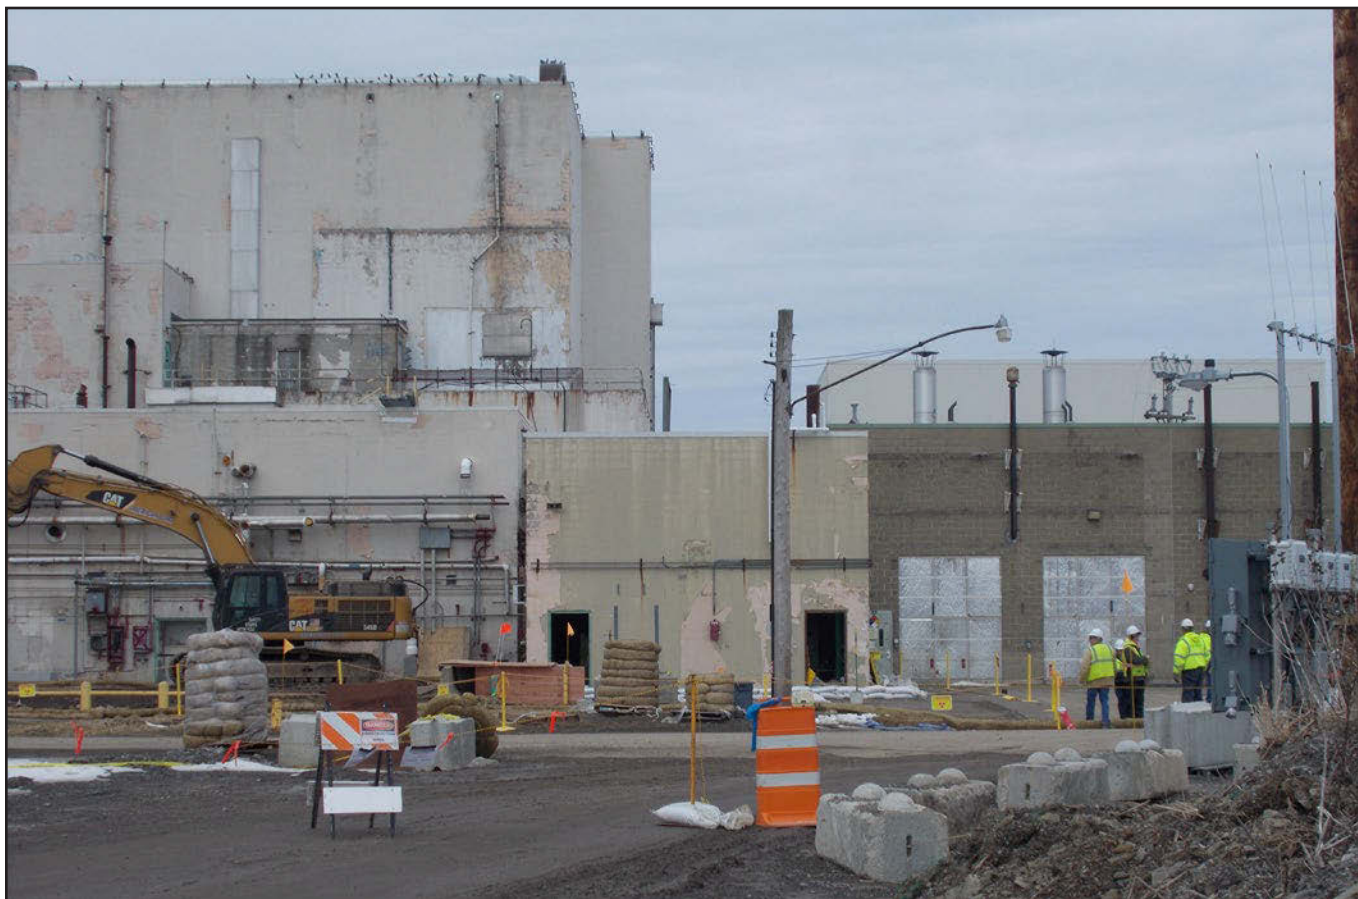
The main plant utility room (left), laundry room (middle), and utility room extension (right) as seen before demolition began. The main plant process building is seen in the background.

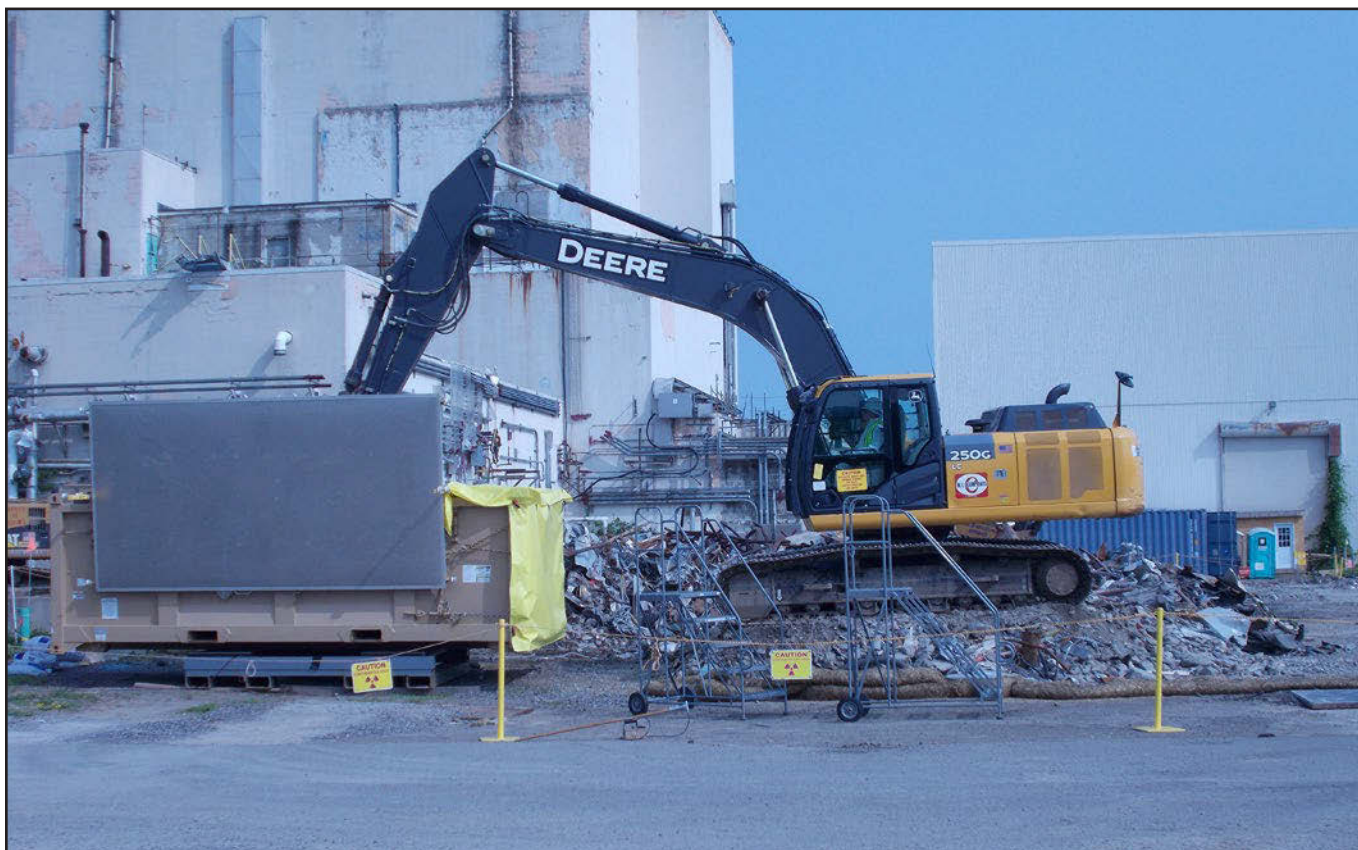
Debris from the demolition is loaded and packaged for off-site disposal. Scott Anderson, president of cleanup contractor CHBWV, said, "Protecting the workforce and the environment were paramount during the demolition process. We completed this challenging milestone using lessons learned and look forward to applying those best practices on future projects." ■
